**GRISHAM LAKE DAM**

**HOWELL COUNTY, MISSOURI**

**MO 31574**

**PHASE 1 INSPECTION REPORT  
NATIONAL DAM SAFETY PROGRAM**

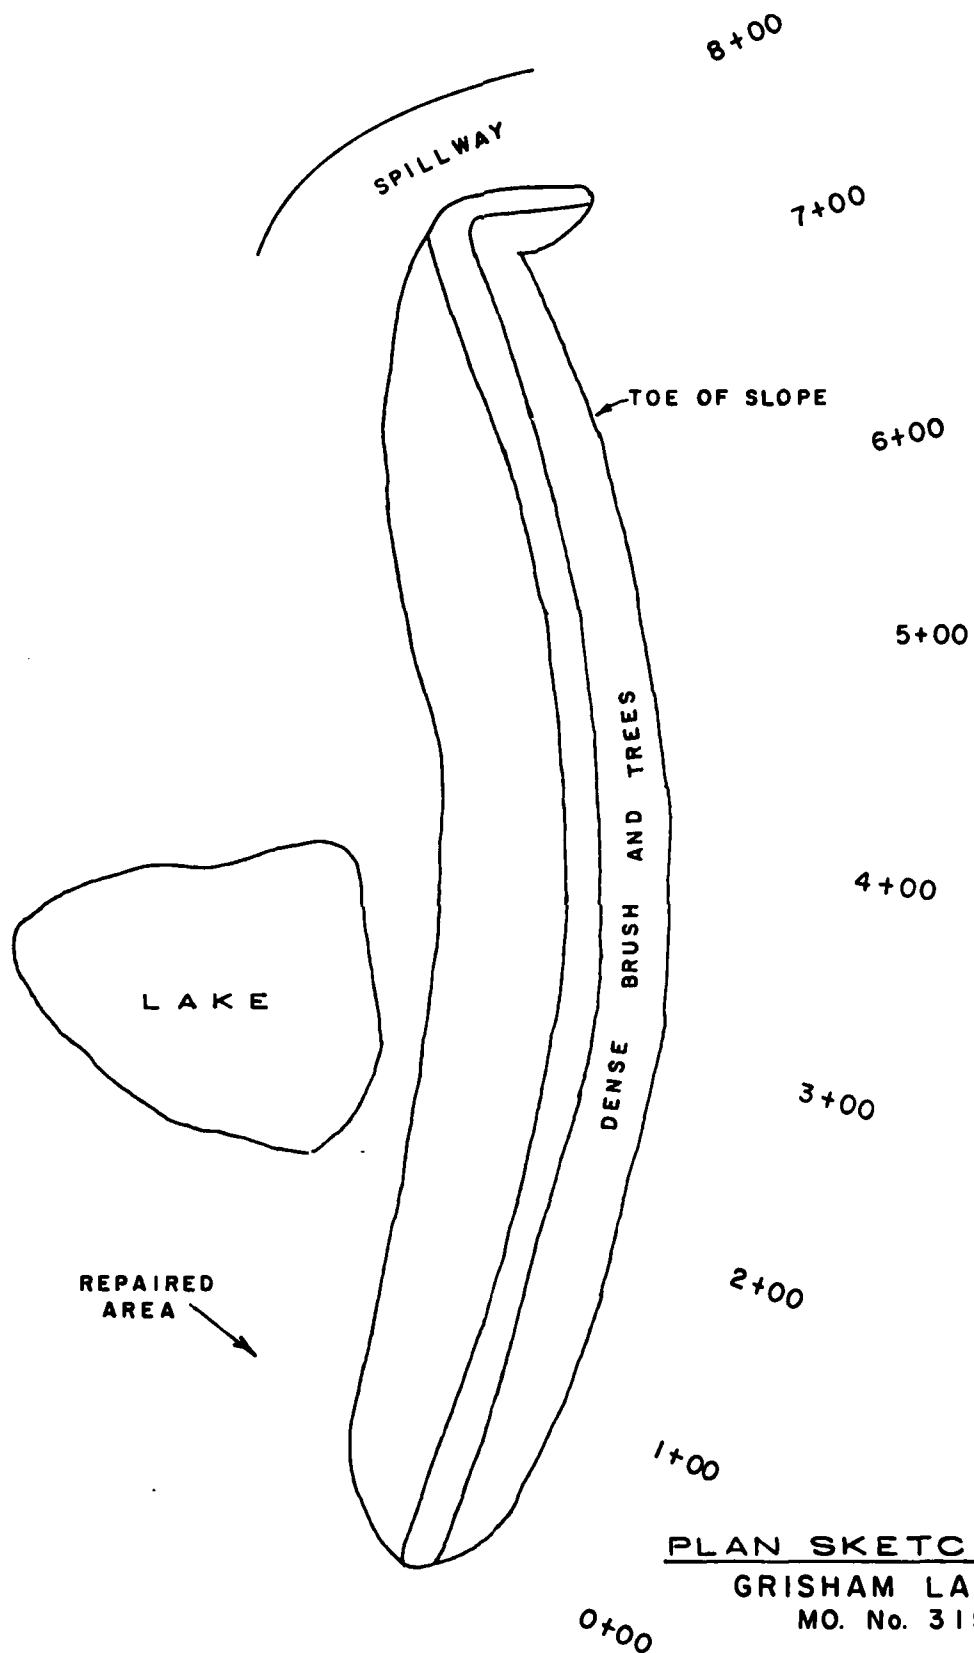
PLAN SKETCH OF DAM  
GRISHAM LAKE DAM  
MO. No. 31574
